WATER PUMP - IMPELLER

VOLVO MD6A WATER PUMP

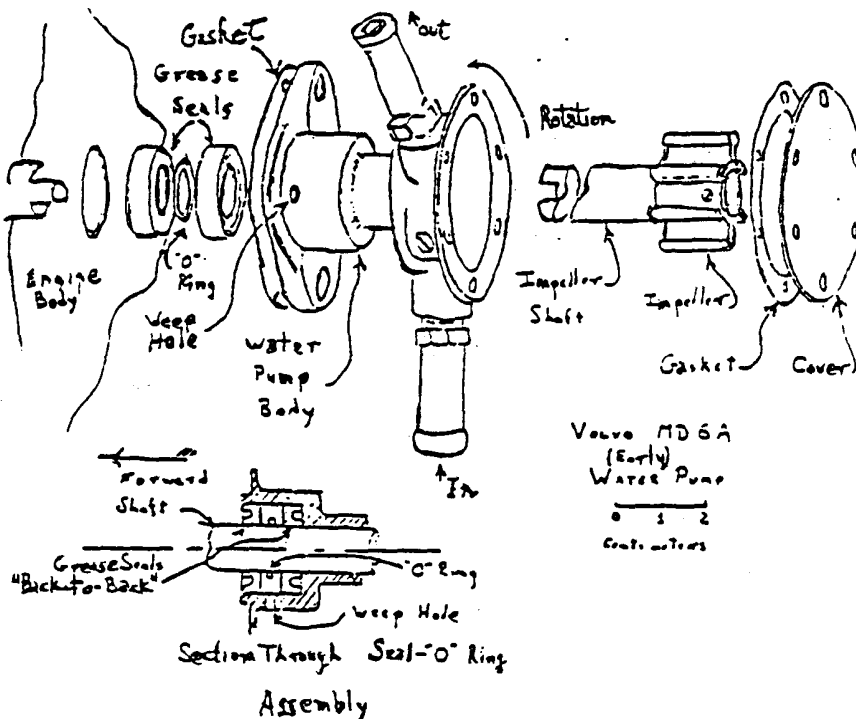
The accompanying diagram shows the construction of the water pump. The Volvo parts book makes a distinction between early and late model engines so be sure to have your engine serial number when you go for parts.

When replacing or servicing the impeller, do not withdraw the impeller and shaft further than to have the impeller emerge from the housing, otherwise the "O" ring will be pulled off the shaft and drop between the seals. Removal of the water pump from the engine will then become necessary.

For any servicing of the water pump, I recommend removing the insulation--covered boards that form the rear partition of the engine compartment. There are about 8-10 flat head brass wood screws to remove and the time needed is well worth it.

Removal of the water pump from the engine is not very difficult. First remove both water hoses from the pump by loosening the hose clamps and then twisting the hoses off. Removal of two hex-head machine bolts will then permit you to remove the pump. In my case the bolts were not at all tight, so they could be removed by hand once they had been turned about $\frac{1}{4}$ turn.
